Test Report No: WTH1704#3-1
Date: 12/06/2017
Testing of: Single side hung casement window
Tested to: PAS 24 : 2016
Prepared for: Smartframes South West Ltd

Test Report No. WTH1704#3-1	Page 2 of 12
Testing of Single side hung casement window	
Testing to PAS 24 : 2016	Date 12/06/2017

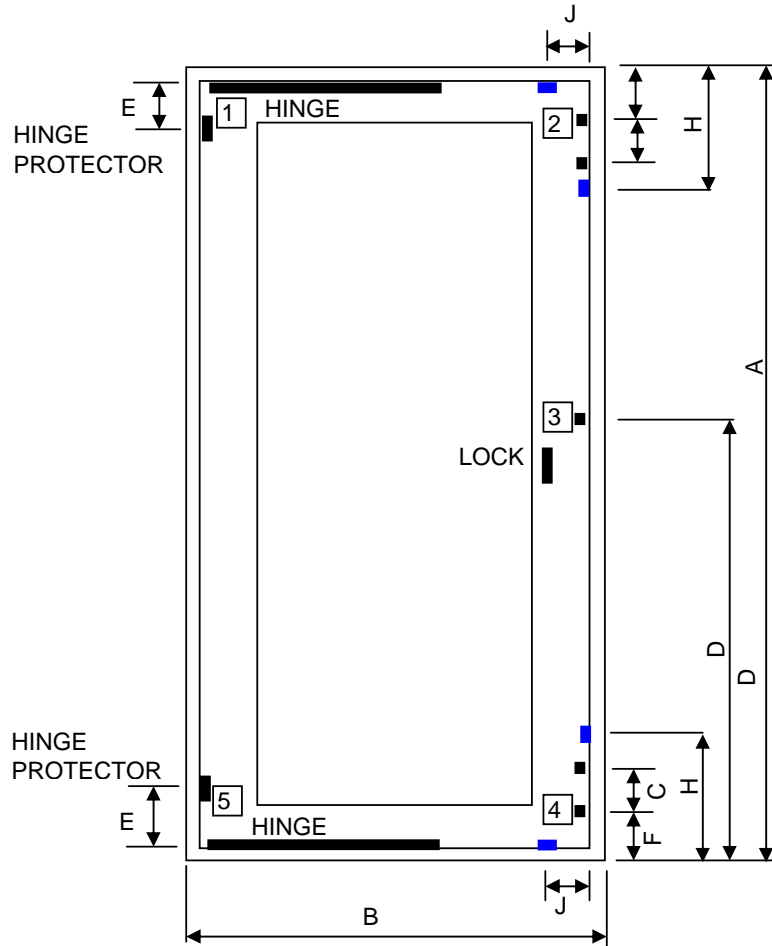
TEST WINDOW DRAWING

■ Run up blocks

- A = 1260 mm
- B = 700 mm
- C = 75 mm
- D = 630 mm
- E = 95 mm
- F = 105 mm
- G = 85 mm
- H = 220 mm
- J = 80 mm

Laboratory conditions	Temperature	23°C	Humidity	47%RH	Date	12/06/2017
Load location	Parallel to plain load		Perpendicular to plain load		Observations / Assessment	
1 Top hinge corner & hinge protector vert down	1000 N (10 sec)		3000 N (10 sec)		Held for 10 seconds	
1 Top hinge corner & hinge protector Horizontal	1000 N (10 sec)		3000 N (10 sec)		Held for 10 seconds	
2 Top lock corner & locking cams Vertically down	1000 N (10 sec)		3000 N (10 sec)		Held for 10 seconds	
2 Top lock corner & locking cams Horizontal	1000 N (10 sec)		3000 N (10 sec)		Held for 10 seconds	
3 Centre lock point Vertically down	1000 N (10 sec)		3000 N (10 sec)		Held for 10 seconds	
3 Centre lock point Horizontal	1000 N (10 sec)		3000 N (10 sec)		Held for 10 seconds	
4 Bottom lock corner & locking cams Vertically down	1000 N (10 sec)		3000 N (10 sec)		Held for 10 seconds	
4 Bottom lock corner & locking cams Horizontal	1000 N (10 sec)		3000 N (10 sec)		Held for 10 seconds

5 Bottom hinge corner & hinge protector vert up	1000 N (10 sec)		3000 N (10 sec)		Held for 10 seconds	
5 Bottom hinge corner & hinge protector Horizontal	1000 N (10 sec)		3000 N (10 sec)		Held for 10 seconds	
	1000 N (10 sec)		3000 N (10 sec)

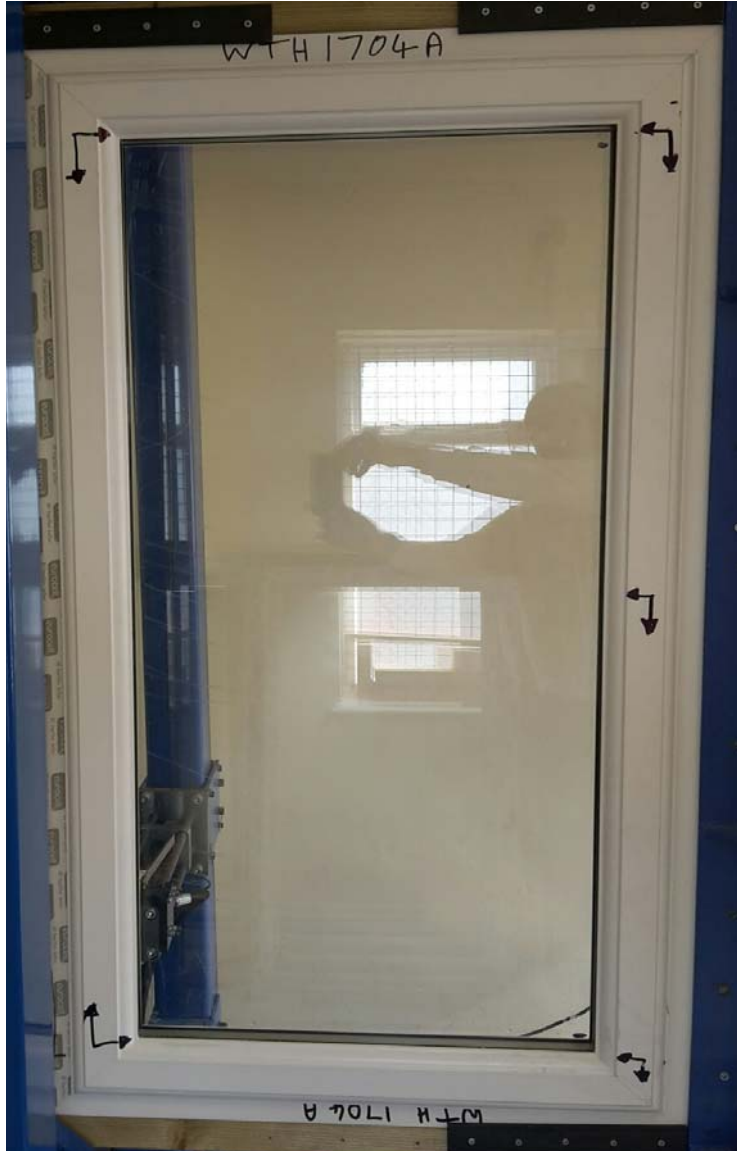
PICTURE OF TEST WINDOW

Sample details	Single side hung projecting casement window
Fabricator	Smartframes South West Ltd
Material:	PVC-U, fully welded. Eurocell eurologic Eurocell profile numbers; Frame - 7721 Sash - 7705 Frame reinforcement - EWS821P Sash reinforcement - EWS805P
Finish	White
Lock & keeps	Lock - Nico Multilock 1150, part no 9191022S5 Keeps - Nico cast zinc, part nos 9105 at each end 9005 in centre
Hinges & protectors	Hinges - Nico 16" side hung egress, part no Hinge protectors - Nico Xtra bolt, part no 8000
Handle	ERA Connoisseur inline
Fixings	Lock - UKF Windowmaster 3500/25Z (4.3 x 25mm c'sk head pierce point) Hinges - UKF Windowmaster 3577/13Z (4.3 x 13mm pan head pierce point) into frame, 3577/25Z (4.3 x 25mm pan head pierce point) into sash. Hinge protectors - UKF Windowmaster 3500/25Z (4.3 x 25mm c'sk head pierce point) into frame and sash.
Weather sealing	Co-extruded gaskets
Glass (or infill)	4-20-4mm clear toughened glass unit

Glazing system	Internally bead glazed
Sample dimensions	1260mm(h) x 700mm(w) Sash rebate size 1160mm(h) x 595mm(w)
Additional information	Run up blocks - Eurocell part no EWS7202
